PHOTOGRAPHIC INTERPRETATION REPORT

# REOPENING OF ENEMY ROAD NET, LAOS PANHANDLE

DECEMBER 1969

NATIONAL PHOTOGRAPHIC INTERPRETATION CENTER

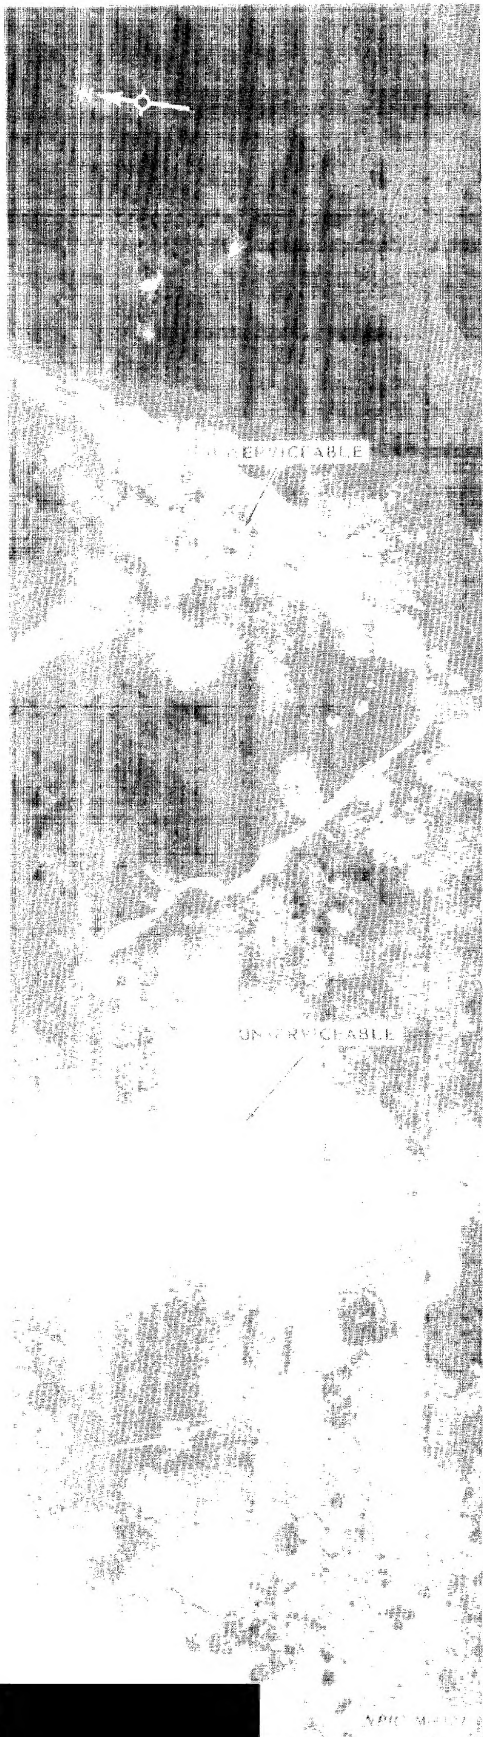
25X1D The Ho Chi Minh Trail was completely closed in [REDACTED] for the first time since it was built (Figure 2, Route 165). This was because of the unusually heavy rains, especially during the early part of the rainy season, and the increased number of bombing sorties as compared to last year.

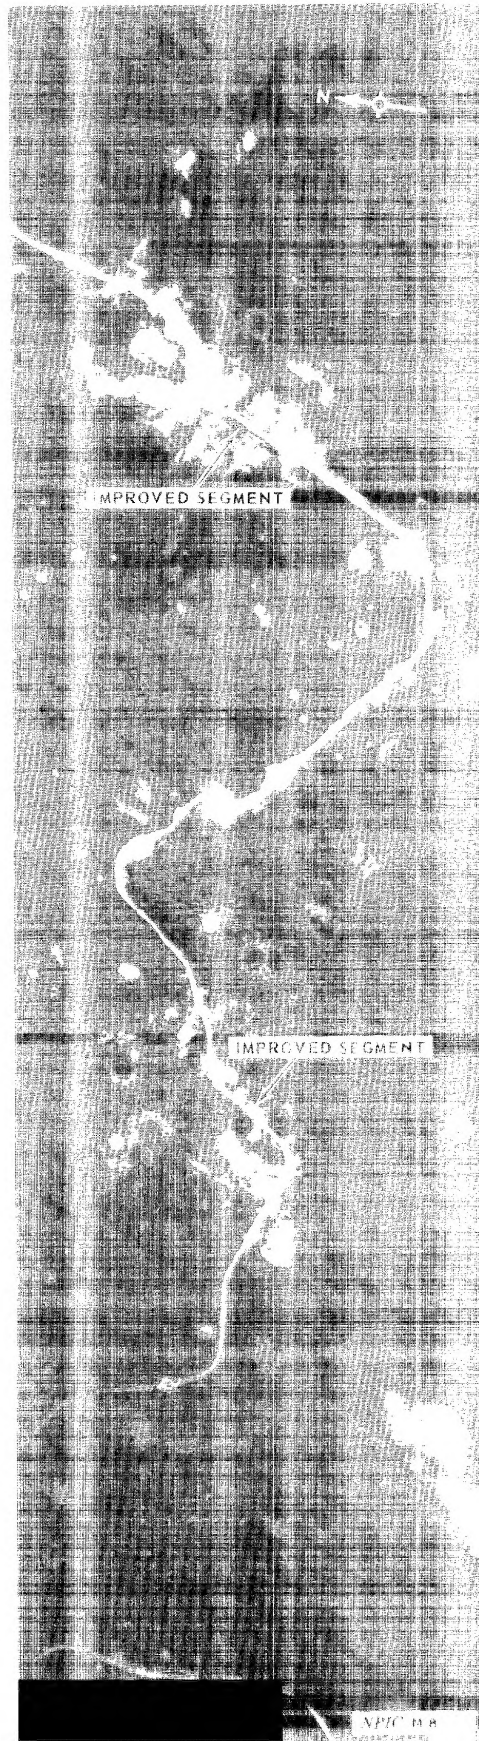
25X1D In [REDACTED] only small segments of the road net were reopened for local traffic. However, during [REDACTED] and the first week of [REDACTED], a concerted effort to reopen the entire network was undertaken (Figure 3, Route 165). [REDACTED] 25X1D [REDACTED] moderate to heavy use of the Mu Gia and Ban Karai Pass roads was evident. The southern roads, Routes 922, 92, 96, and 165, appeared to be only lightly used. It appears that the alternate routes and bypasses, as well as the main roads, are being reopened. For example, two bypasses at Ban La Bay have been reopened, with initial improvement observed on a third. However, there is no evidence of construction of new storage and truck park areas along the infiltration network.
